Contract #: 04-0120F4Cty: SF/ALA Rte: 80 PM: 13.2/13.9File #: 99.28**WELDING INSPECTION REPORT****Resident Engineer:**Siegenthaler, Peter**Address:** 333 Burma Road**City:** Oakland, CA 94607**Report No:** WIR-024155**Date Inspected:** 31-May-2011**Project Name:** SAS Superstructure**OSM Arrival Time:** 700**Prime Contractor:** American Bridge/Fluor Enterprises, a JV**OSM Departure Time:** 1900**Contractor:** Zhenhua Port Machinery Company, Ltd (ZPMC) Chanxing Island**Location:** Shanghai, China**CWI Name:** Mr. Shi Lei**CWI Present:** Yes No**Inspected CWI report:** Yes No N/A**Rod Oven in Use:** Yes No N/A**Electrode to specification:** Yes No N/A**Weld Procedures Followed:** Yes No N/A**Qualified Welders:** Yes No N/A**Verified Joint Fit-up:** Yes No N/A**Approved Drawings:** Yes No N/A**Approved WPS:** Yes No N/A**Delayed / Cancelled:** Yes No N/A**Bridge No:** 34-0006**Component:** OBG Segment**Summary of Items Observed:**

OBG Trial Assembly Yard

WELDING INSPECTION REPORT

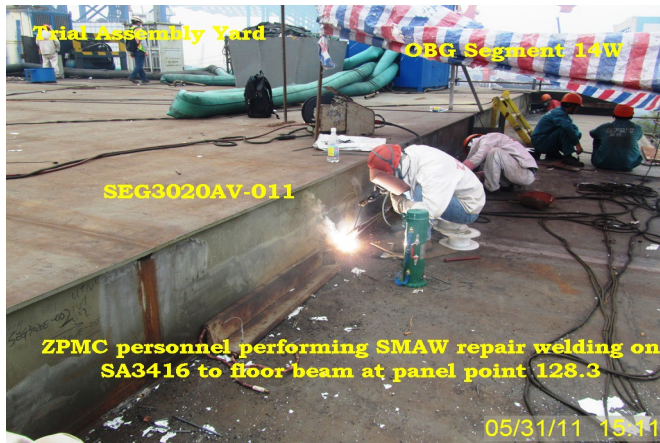
SMAW welding of weld joint SEG3020AV-006 and 011 located on SA3416 to floor beam at panel point 128.3 of OBG Segment 14W. ZPMC Welders are identified as 067572 and 066675. ZPMC Quality Control (QC) is identified as Mr. Zhu Lin. The welding variables recorded by QC appeared to comply with the Applicable WPS-345-SMAW-1G-(1F)-FCM-Repair-1, which is used as per Welding Repair Report (WRR) B-WRR-21133. See the attached picture.
